Role of Geospatial Information for Disaster Risk Management as Exemplified in Recent Large Earthquakes in Japan

UNE Hiroshi^{a*} and NAKANO Takayuki^b

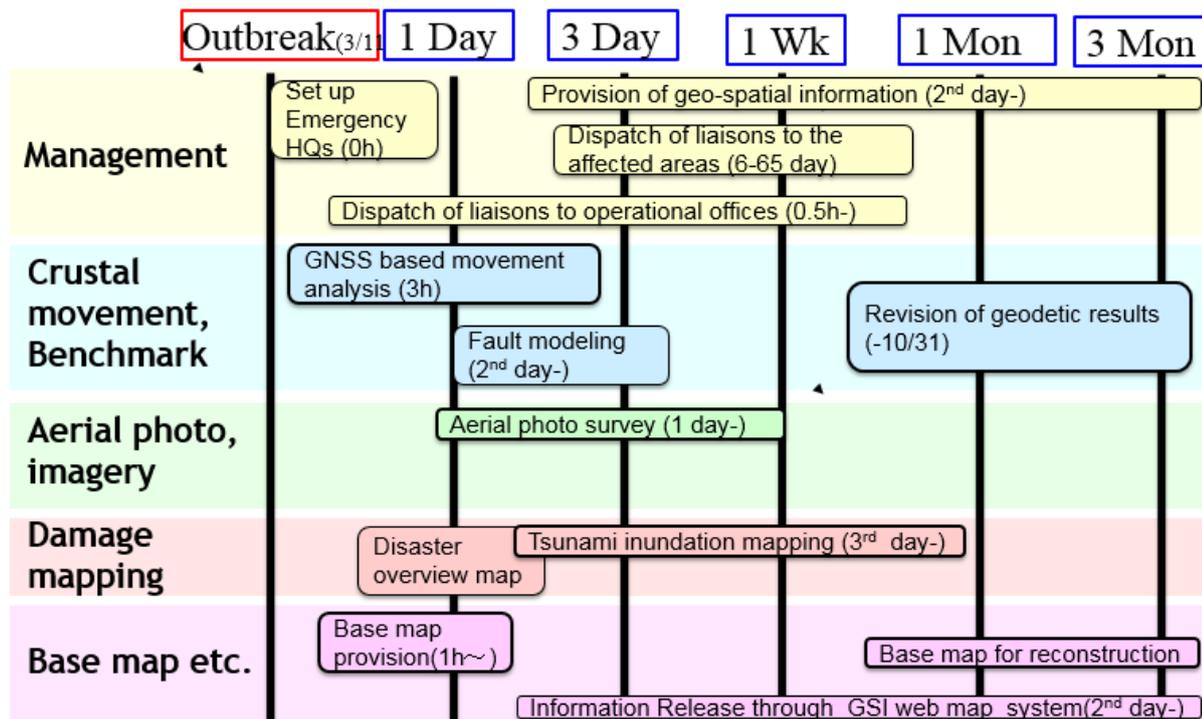
Figure 2. Emergency response activities of GSI (compiled by GSI)

Just after the occurrence of the Tohoku Earthquake, the GSI went into emergency status and immediately set up an emergency headquarters (EHQ) to serve as the decision-making body for disaster operations. The first EHQ meeting was held at 3:10 PM, within thirty minutes of the main shock. In accordance with the decisions of the EHQ, the GSI took various actions to support the victims and damaged regions by surveying and providing geospatial information, such as distributing maps and aerial photos, observing crustal deformation and mapping inundation areas, under full collaboration with private surveying companies and related organizations. Among its efforts, three major emergency response activities were 1) provision of maps, 2) detection of ground surface movement using Global Navigation Satellite System (GNSS) control point network, and 3) aerial surveys including interpreting photos of damaged areas (Figure 2). Immediately after the Tohoku Earthquake, the GSI delivered base maps of damaged areas to relevant government offices, starting from small-scale maps sent to central government offices via the Internet or in the form of paper maps. In addition to the map data, the GSI dispatched liaison staff to those offices to provide services for preparing maps of synoptic views of the damage and recovery status for their briefings. The GSI also dispatched its staff to onsite headquarters of the government for disaster management, with map data and equipment, including computers and large-sized printers to provide paper maps in response to the needs of officials in charge of rescue and relief operations.

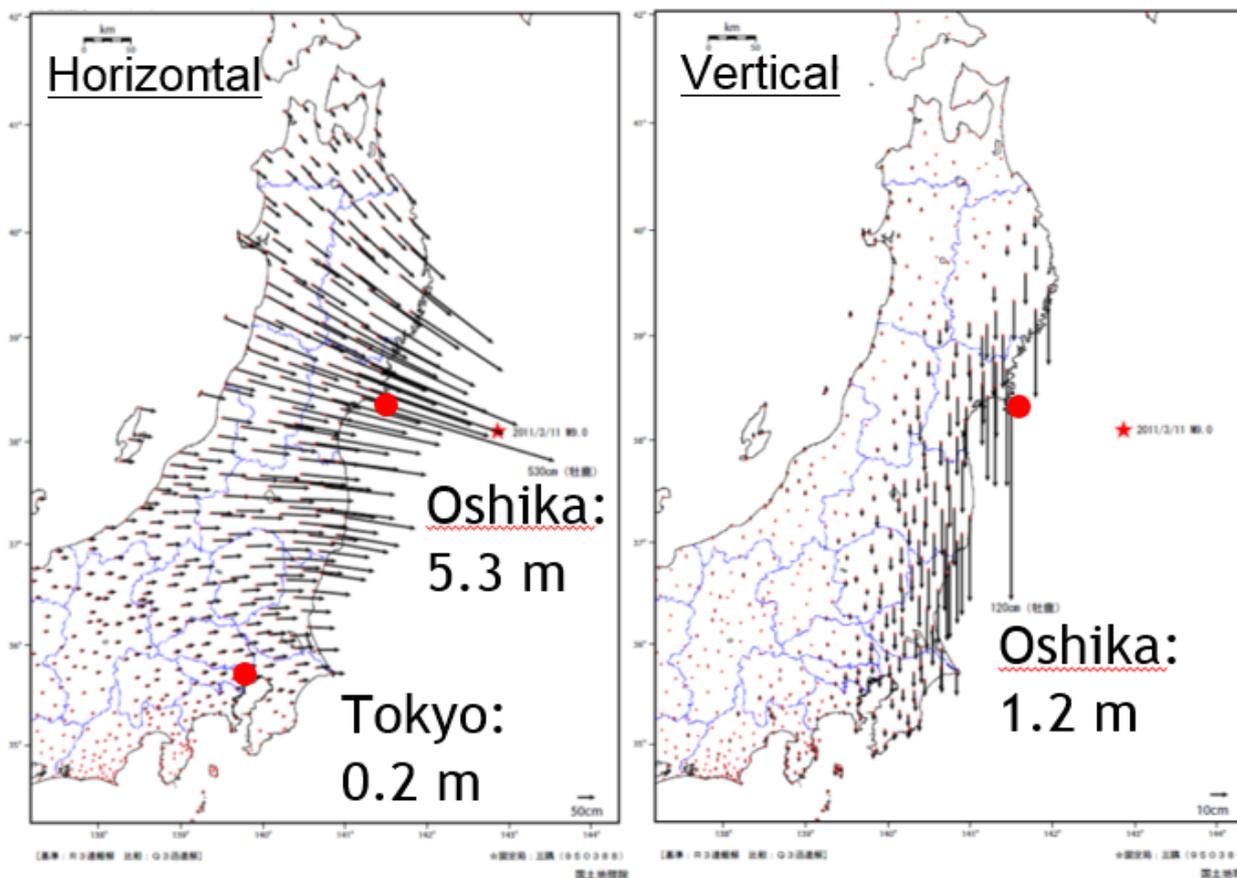
Figure 3. Ground surface movements observed by GEONET. left: horizontal deformation; right: vertical deformation (from GSI web page)

As for the detection of ground surface movement, the GSI made the best use of its GNSS control point network. Since 1995 the GSI has installed GEONET (GNSS Earth Observation Network System), with more than 1,200 GNSS continuous observation stations throughout the country for location reference services and detection of crustal deformation. After the main shock of the Tohoku Earthquake, the GSI made its best efforts to get initial results of ground surface movements within a few hours. Ultimately, analysis of the observed data revealed that the maximum movement was 5.3 meters in the horizontal direction and minus 1.2 meters in vertical (Figure 3).

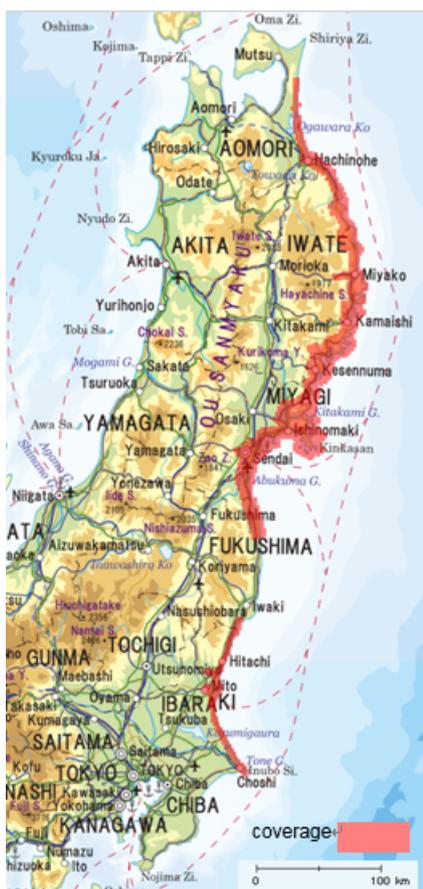
Figure 4. Areas covered by the aerial photographs (compiled by GSI)

around the crippled nuclear reactors. The GSI possesses its own aircraft "Kunikaze 3," and a special crew team for aerial surveys. However, the damaged area to be covered was assumed to be extremely large, obviously far beyond the coverage ability of a single aircraft. In case the GSI is not available to implement emergency tasks when a disaster occurs, it has entered into an "Agreement on Emergency Photography for Disaster Occurrence" since 2005 with private surveying companies to receive assistance in conducting emergency photography efficiently. Immediately after the earthquake, the GSI decided to request the collaborative works based on this agreement to conduct coordinated emergency photography. The weather during the next few days was very cooperative, and the air crew teams were able to take aerial photos of major damaged areas on 12 and 13 March. The remaining areas were covered in subsequent survey missions by the GSI. Such a collaborative framework will be needed to function well on occasion of expected future large-scale earthquakes and tsunamis such as Nankai Trough Earthquake. In addition, the GSI is promoting development of applications for latest remote-sensing technology such as the synthetic aperture radar imaging from aerial platforms in case of disasters occurring under bad weather or at night. As a result of the emergency photography, colour aerial photographs of a total of approximately 6,900 km² of the affected areas were taken, mostly at a scale of 1:20,000 (Figure 4). The acquired data were processed as quickly as possible, mobilizing resources through the night. Aerial photo data were delivered to major governmental organizations and uploaded to the GSI's website the next day, 14 March. The results enable comparison with photos taken before the earthquake to highlight the damage caused by the tsunamis (Figure 5).

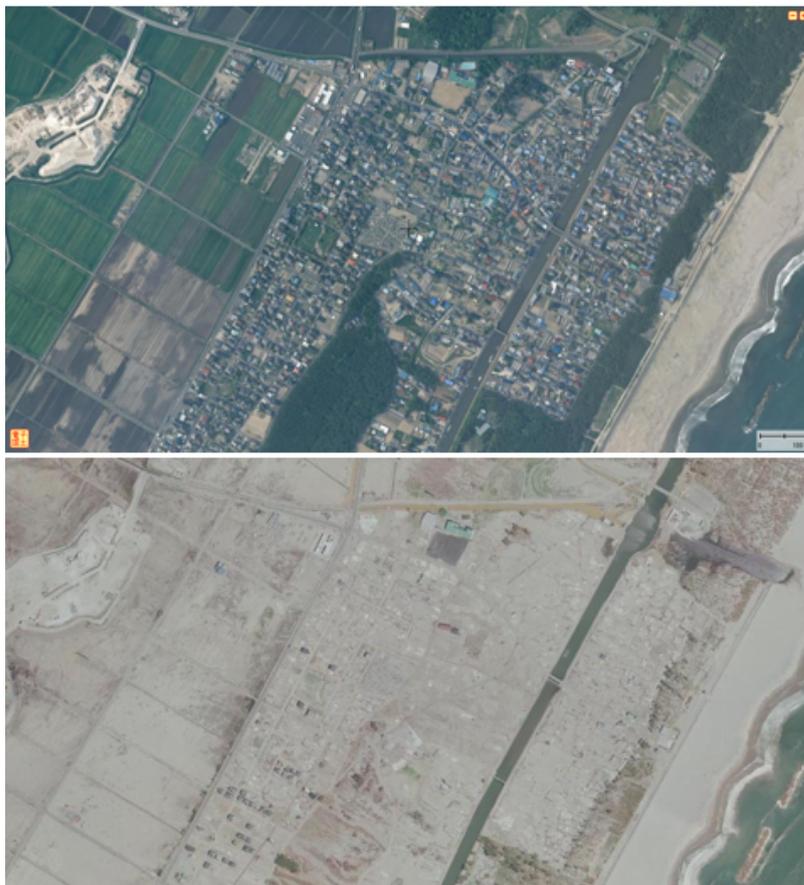
Figure 5. An example of aerial photo images of a damaged area (Natori City) taken after the Tohoku Earthquake by GSI. upper: before the tsunami; lower: after the tsunami (from GSI web page)

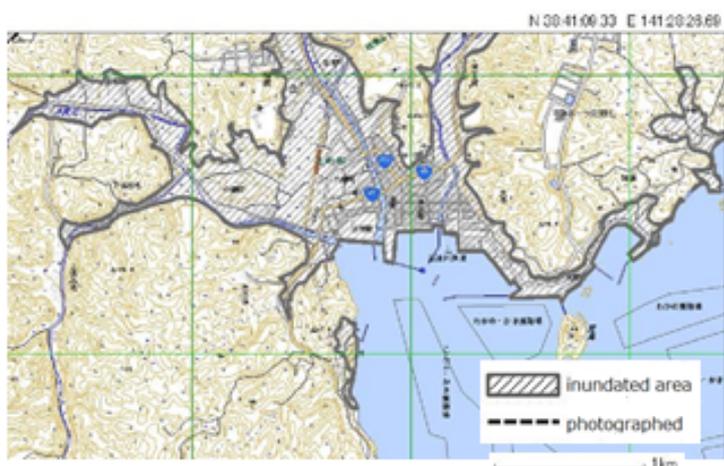
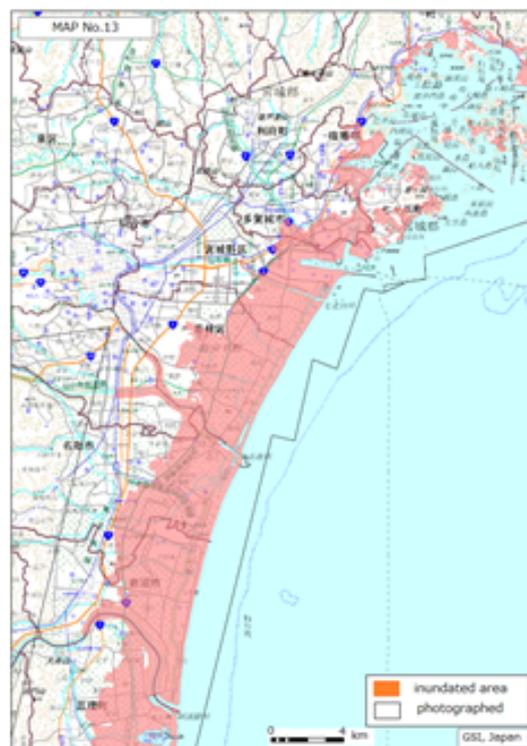
Figure 6. An example of “tsunami flood area overview map” compiled on 1:25,000 topographic map (left) and digitally copied to 1:100,000 scale map (right) (from GSI web page).

The GSI created a "tsunami flood area overview map" to ascertain the tsunami damage situation. As the aerial photos came in, the GSI staff started working on photo interpretation of the inundated areas and compiled the results on 1:25,000 topographic maps using GIS software. Then the results were digitally copied to 1:100,000 scale maps for a better understanding of whole picture of the damage. These were uploaded on GSI's website (Figure 6). The results showed that the inundated areas came to as much as 561 km² in total.

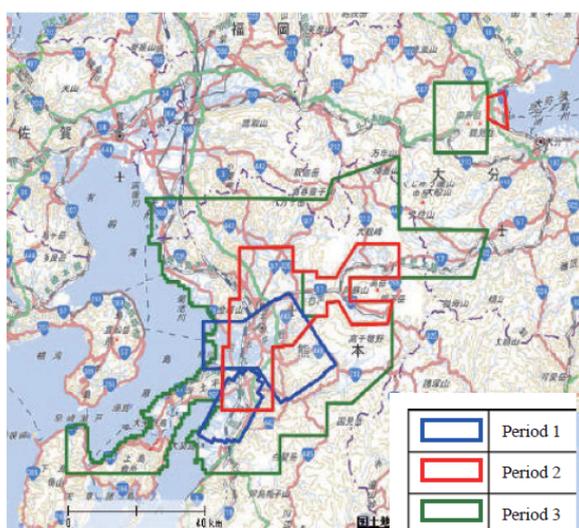
Figure 7. Areas of aerial photos (compiled by GSI)

As the initial stage, aerial photos were taken in three periods: (1) next day of the first M.6.5 earthquake occurred on April 14; (2) the day of the main-shock M.7.3 on April 16, and (3) April 19 and 20 (Figure 7). Fresh aerial photos are essential for understanding the emergency status. For example, we found some scars on the upper part of the slope through our photo interpretation and informed the danger to local authority (Figure 8).

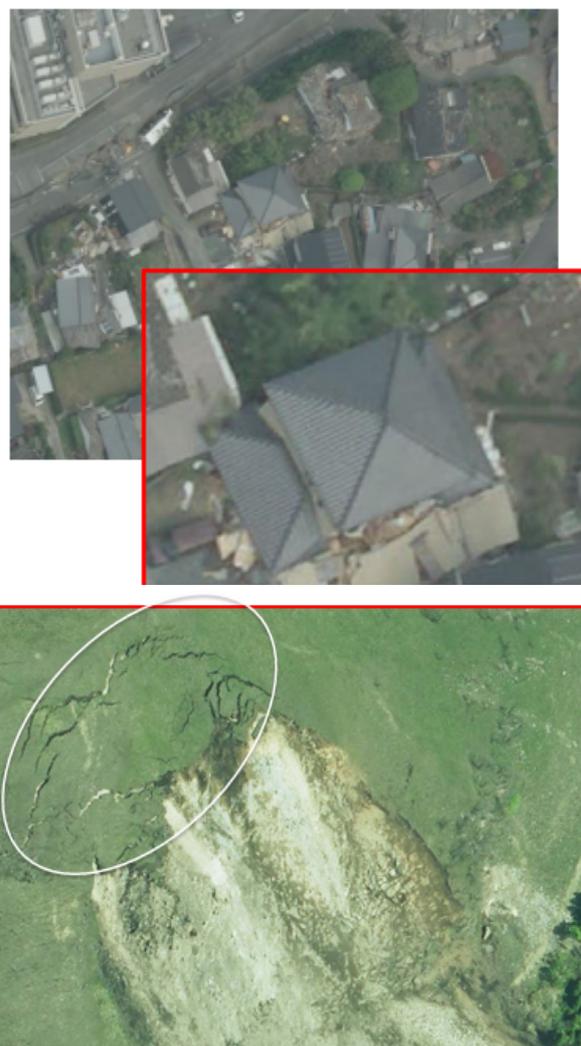
Figure 8. Examples of aerial photos.
upper: collapsed buildings, lower: cracks on the slope
(from GSI web page)

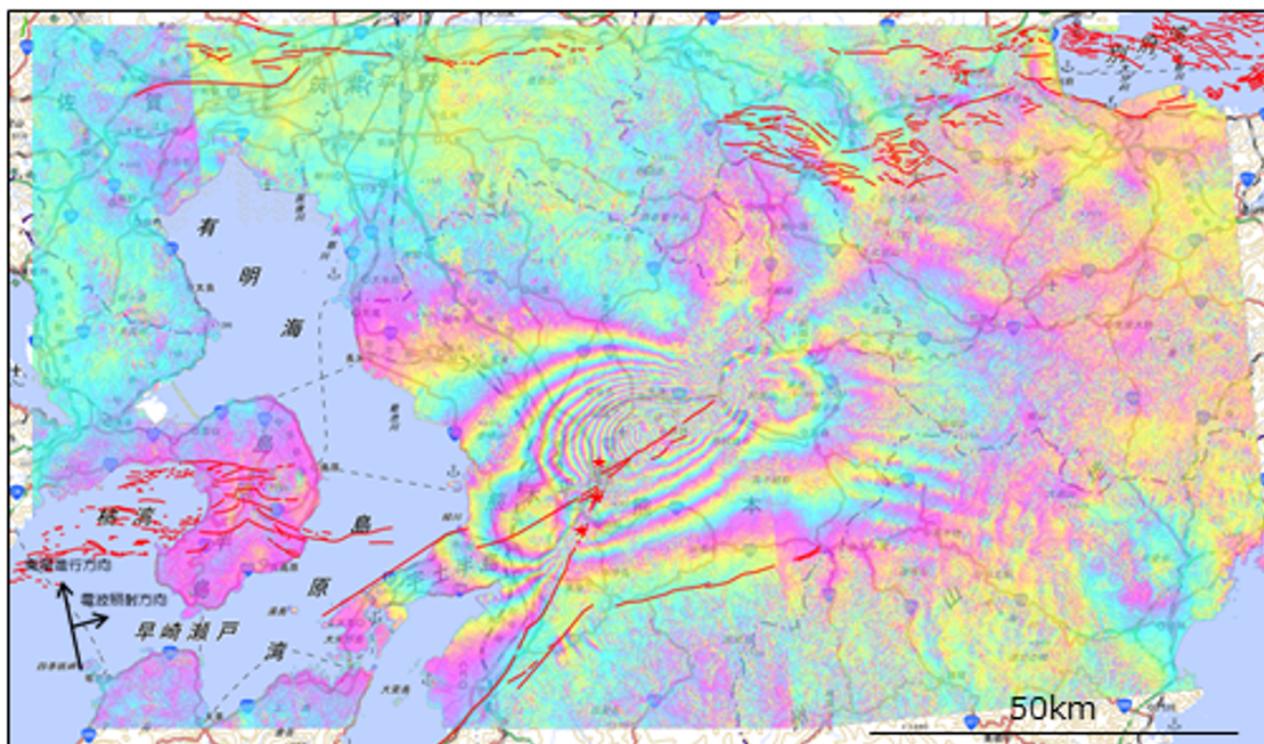
Figure 9. SAR interferogramme (from GSI web page)

SAR interferometry (InSAR) using the data from the Advanced Land Observation Satellite 2 (ALOS-2), launched and operated by Japan Aerospace Exploration Agency (JAXA) provided spatial distribution of the detailed co-seismic deformations caused by the Kumamoto Earthquake. Displacements over 2 m were clearly seen after the main shock. This information was utilized in understanding and estimating the mechanism of the earthquake source faults (Figure 9).

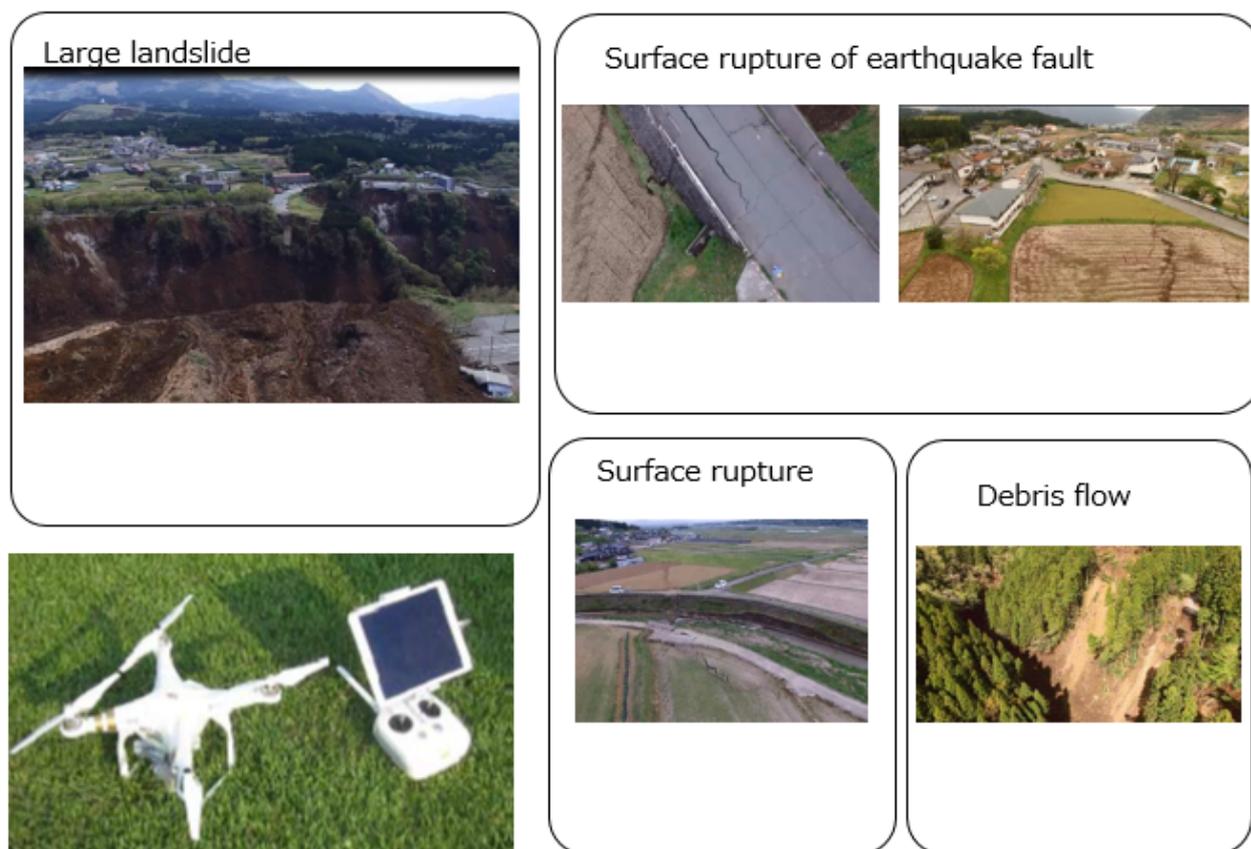
Figure 10. UAV and its results (compiled by GSI)

Another newly introduced technology to grasp the disaster situation is an unmanned aerial vehicle (UAV). It provided high resolution aerial images taken from low altitude. It provided clear images of such as surface ruptures of the earthquake fault and large landslides (Figure 10).

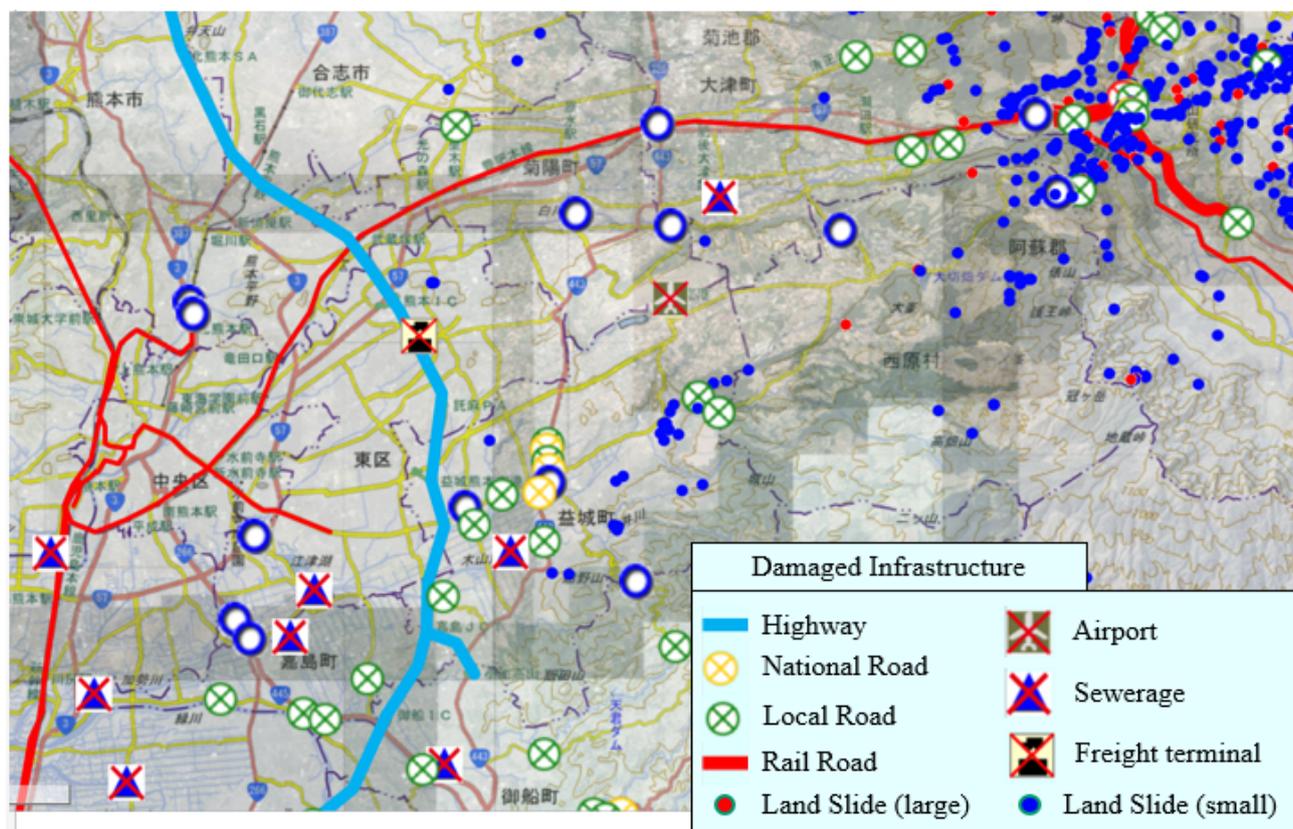
Figure 11. Integration of damage information on GSI Maps (compiled by GSI).

All such information were provided overlain on “GSI Maps”. GSI Maps are web-based maps provided by GSI. Various geospatial information from GSI such as topographic maps, aerial photographs, altitudes, land conditions and disaster information can be overlaid in the display. It allows us to understand the situation by overlaying various location-specific data on a base map on the web, and specify the areas which the activities should be focused on (Fig 11).

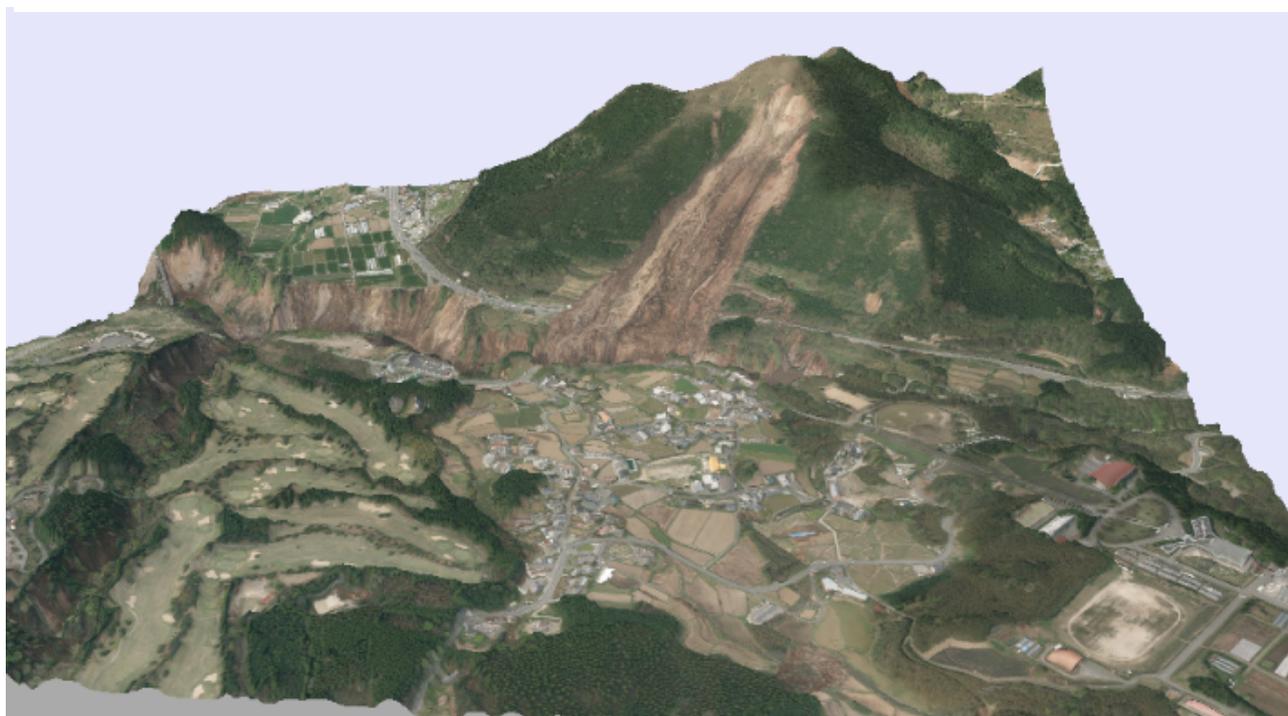
Figure 12. 3D presentation of a landslide. 3D presentation function is automatically facilitated in GSI Maps (from GSI web page).

In addition, GSI Maps has a function to display 3D maps. 3D image enables realistic understandings of the relationship between disaster and topography (Figure 12).
